# CASE STUDY

## Residential Driveway Rehabilitation | Perth, WA | 94.3m<sup>2</sup>

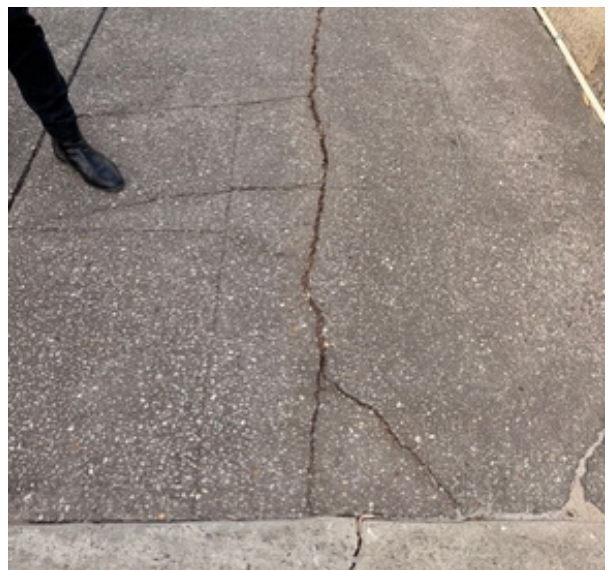
Rather than ripping up the existing driveway and starting again, Rombus Fusion V2 was installed directly over the asphalt.

Low spots were levelled first, then the grid was laid and filled with concrete, creating a new durable surface while keeping the existing driveway underneath and avoiding unnecessary demolition.

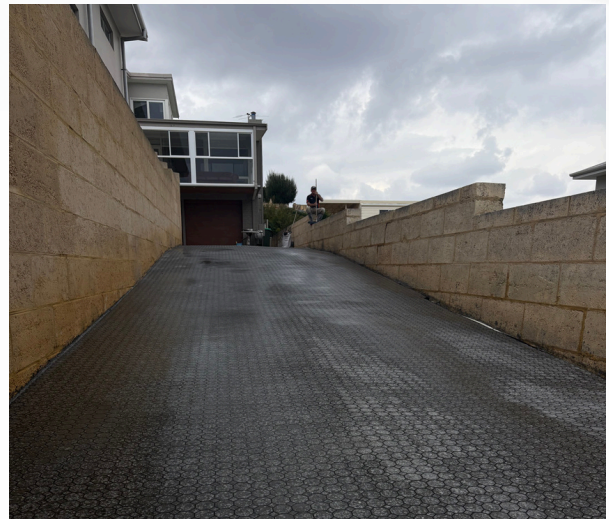
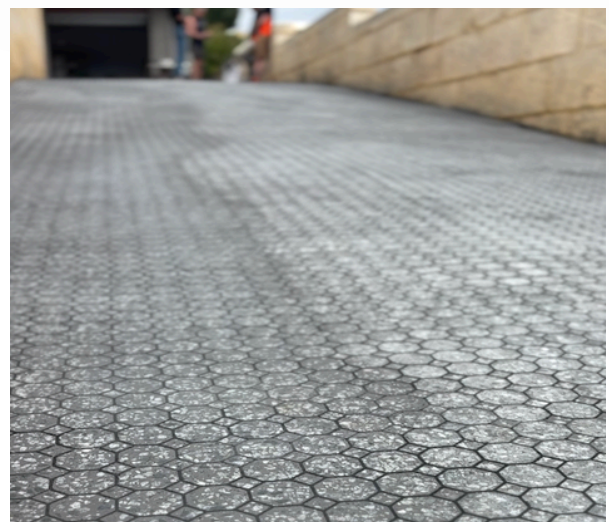
The result was a brand-new, premium concrete driveway without the cost and disruption of a full demolition and rebuild.

- ✓ Installed over existing asphalt
- ✓ No demolition or excavation
- ✓ No expansion joints required
- ✓ Honed and sealed finish
